Docket No. 217 – Development and Management Plan Inspection

Date: January 30, 2004

Inspector: Diana Walden

Location: Norwalk Substation Expansion

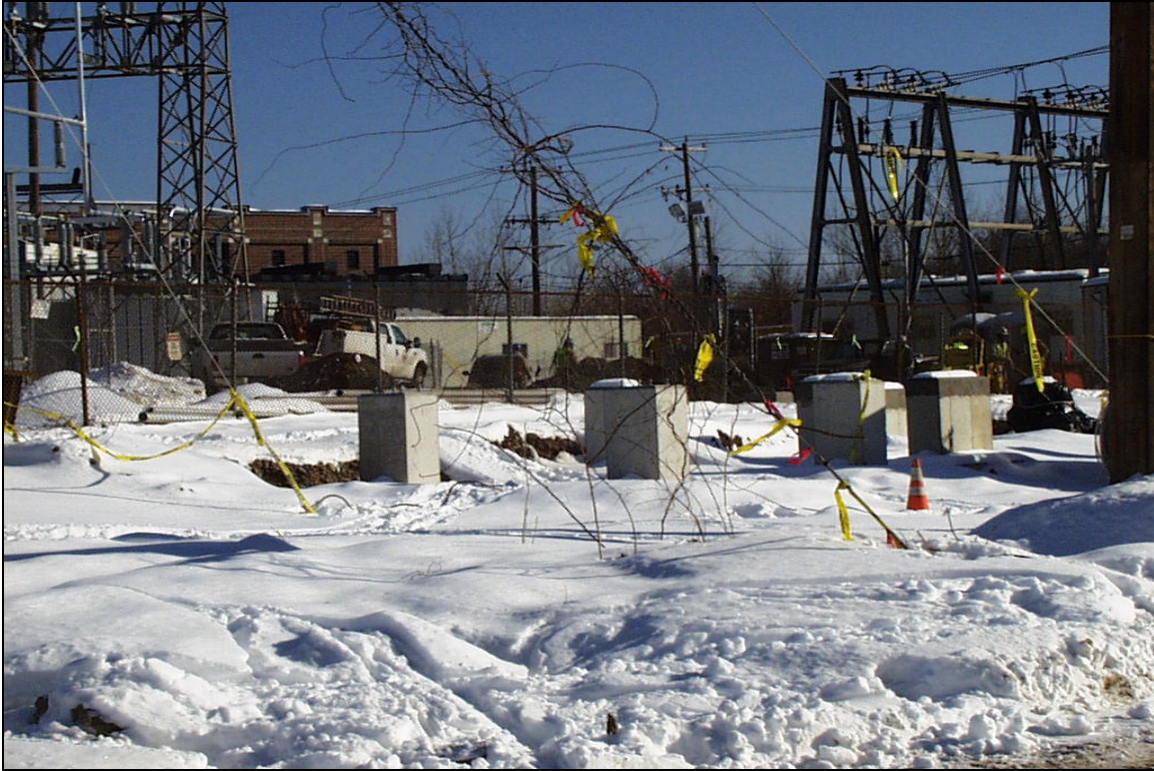
VIEW OF PRECAST FOUNDATIONS INSTALLED OUTSIDE OF THE SUBSTATION YARD. THE EXCAVATION HERE IS COMPLETE BUT IT CONTINUES WITHIN THE YARD. 1/30/04

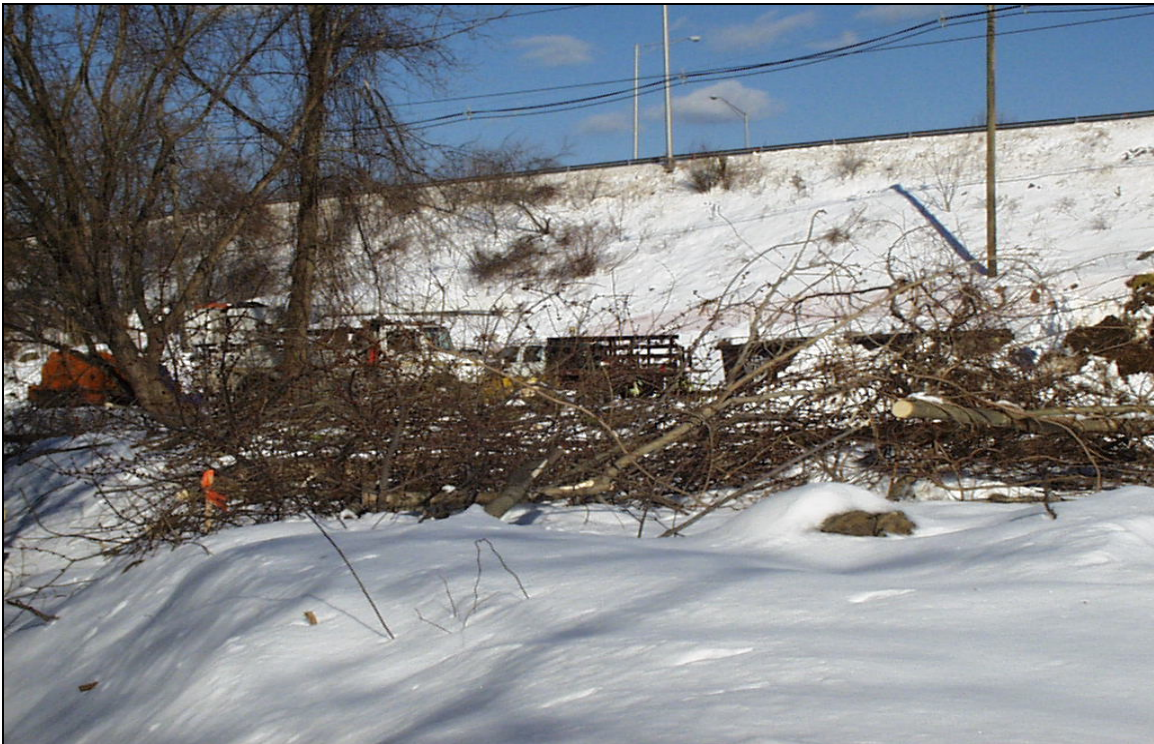
ADDITIONAL PRUNING AND BRANCH CLEARING WAS NECESSARY NEAR THE RIVER BANK AS THEY WERE INTERFERING WITH THE OVERHEAD WIRES. 1/30/04

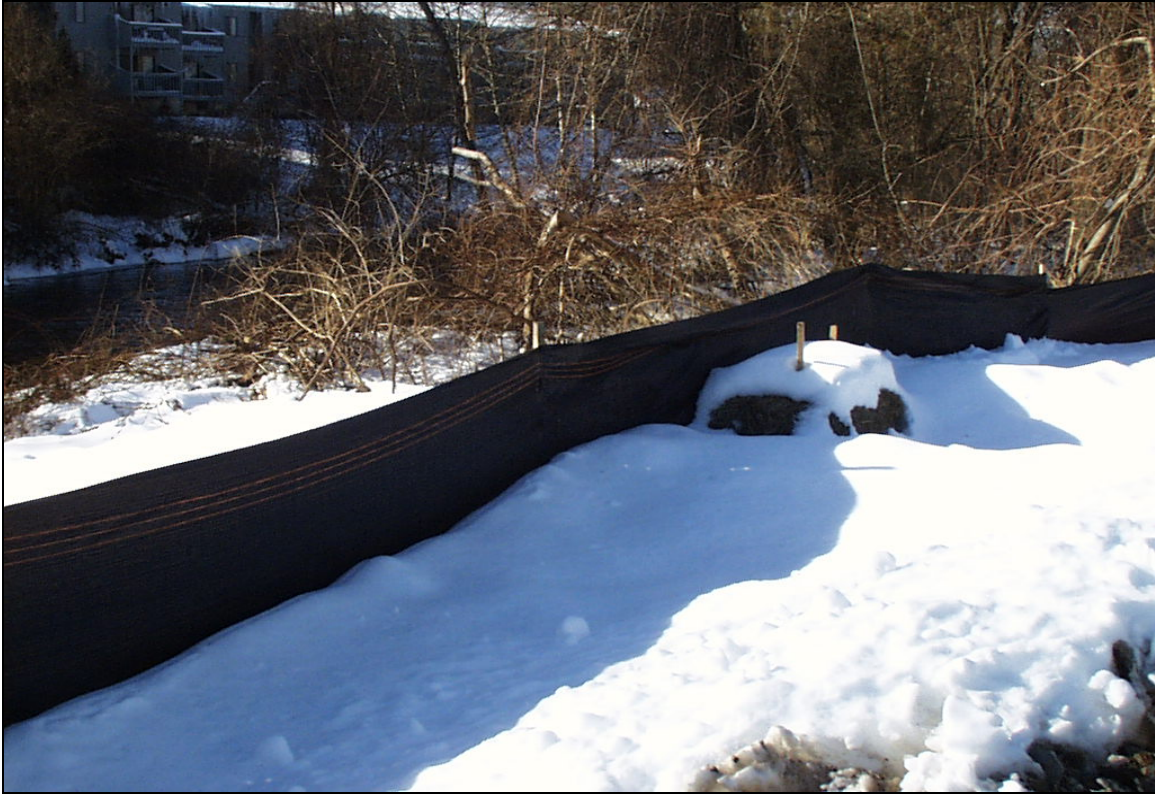
- The temporary sediment basin has been completed and is under snow cover. 1/30/04 - A riprap overflow outlet and overflow pipe have been completed. Silt fence was replaced across this area with an additional haybale check dam in the swale itself. 1/30/04	- Once the basin is in use, monitor outlets for any sediment laden flows 1/30/04 - The silt fence was replaced and is installed well. The area is snow covered and stable at this time. Monitor in the spring following snowmelt. 1/30/04

VIEW OF THE RIPRAP OVERFLOW OUTLET FROM THE SEDIMENT BASIN, COMPLETED AND WITH EROSION CONTROL BACK IN PLACE. 1/30/04

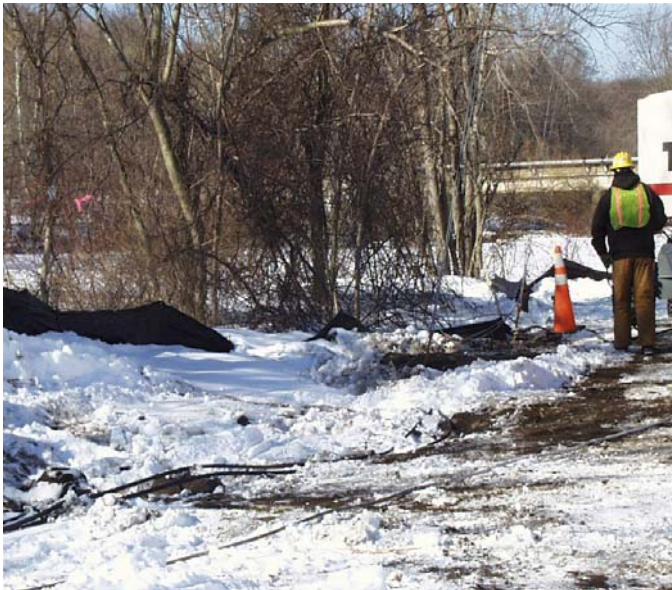
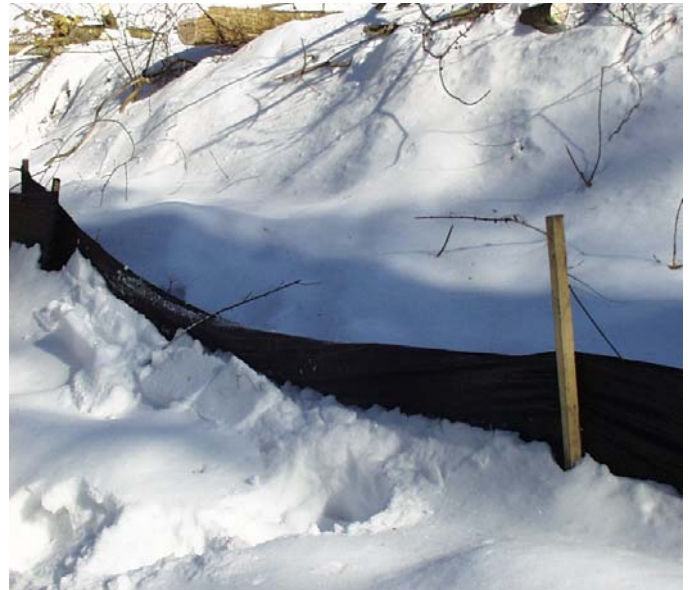
- Silt fence remains in place and is effectively preventing sediment from entering the river. 1/15-1/30/04	- Continue to monitor and maintain as needed. Some spots are very close to the river and will require the most monitoring. 1/15-1/30/04
	-Some areas do require maintenance as the weight of the snow has pulled the fence from the stakes. 1/30/04	The fence should be pulled back up and re-stapled in the necessary areas. Keep up with silt fence repair as needed and be proactive 1/15-1/30/04

VIEW OF SEVERAL LOCATIONS WHERE WEIGHT OF SNOW AND SUBSEQUENT EQUIPMENT MOVEMENT TORE THE SILT FENCE FROM THE STAKES. ALL FENCING WILL BE REPAIRED. 1/30/04

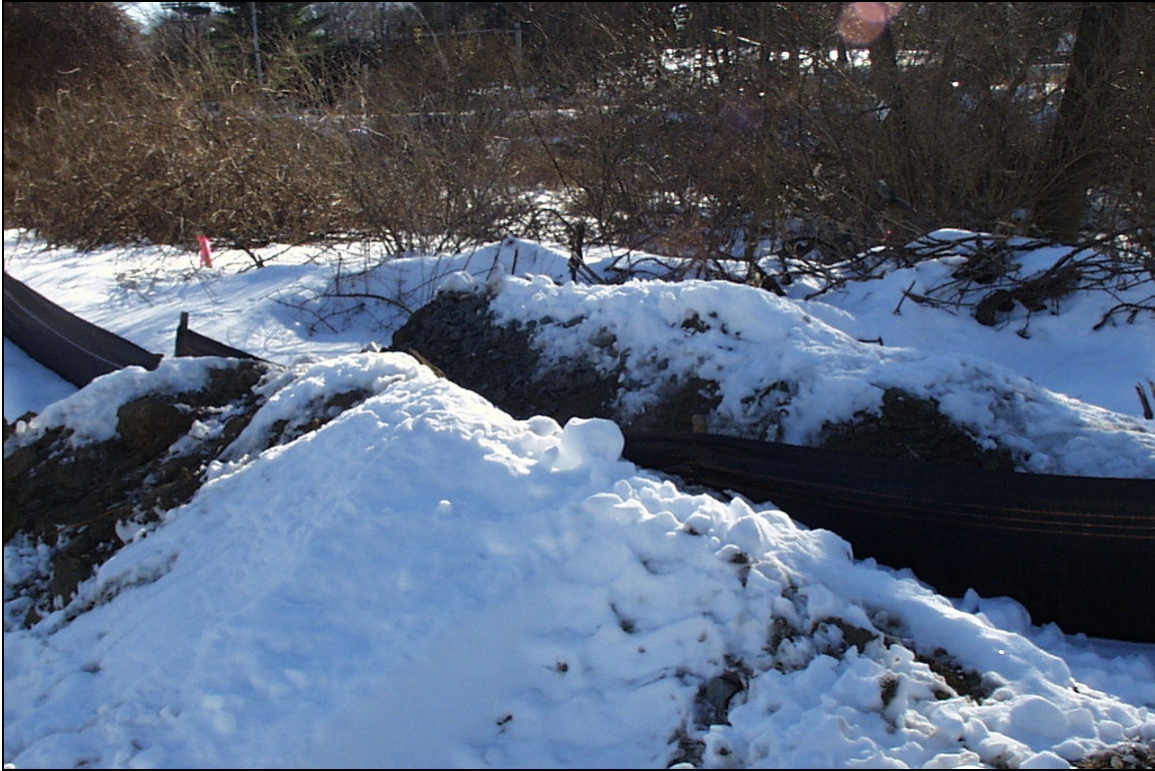
- A small pile of snow, stone and sediment had been placed directly over the silt fence. This may have occurred as a result of snow plowing. 1/30/04	- The pile was brought back on the work side of the silt fence almost immediately after observation. 1/30/04

VIEW OF SNOW/STONE PILE PLACED OVER THE SILT FENCE- LIKELY WHEN SNOW PLOWING. IT WAS BROUGHT BACK INTO THE WORK AREA IMMEDIATELY. 1/30/04

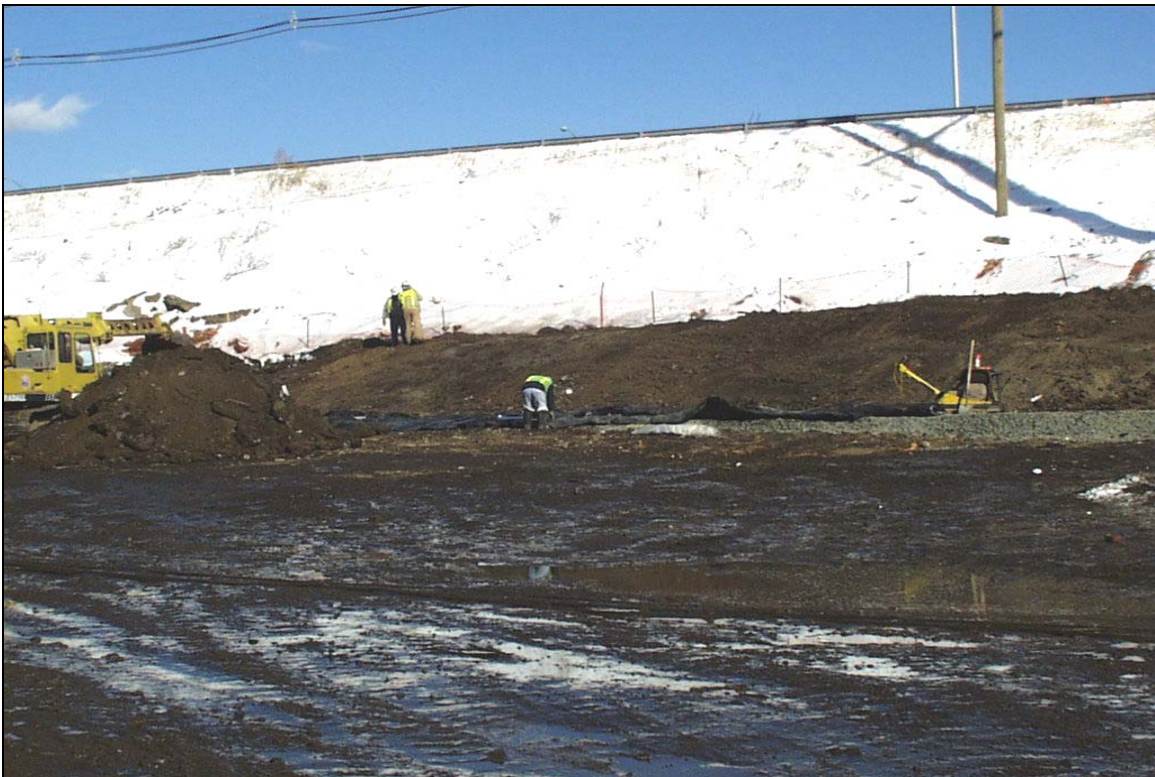
VIEW OF SOIL EXCAVATION AREA AND THE FOUNDATION FOR ONE OF THE
RETAINING WALLS 1/30/04

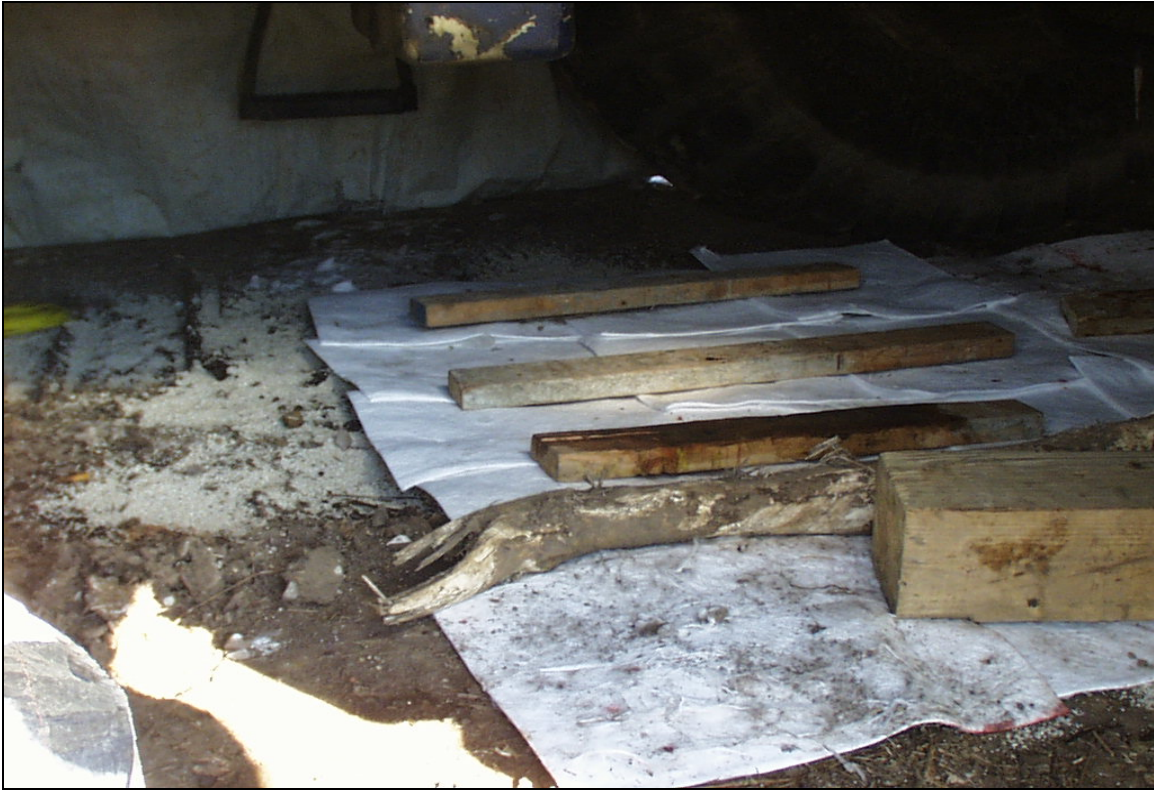
Areas of Inspection	Observation	Recommended Action
	<ul style="list-style-type: none"> - The excavation of the contaminated soil has resulted in more disturbed area on site however, everything is contained appropriately. 1/22-1/30/04 	<ul style="list-style-type: none"> - The areas near the river still appear stable. There is no erosion on the banks or sedimentation. 1/15-1/30/04 - The more vegetation left in place at the river, the more stable the bank will be. 1/30/04
Dewatering	<ul style="list-style-type: none"> - No dewatering activities are occurring at this time 1/30/04 	<ul style="list-style-type: none"> - None at this time 1/30/04
Blasting	<ul style="list-style-type: none"> - No blasting is occurring on site at this time 1/30/04 	<ul style="list-style-type: none"> - None at this time 1/30/04
Spills	<ul style="list-style-type: none"> - One spill was reported to the office this morning prior to inspection. A hose on a crane broke and there was approximately one gallon of hydraulic fluid spilled on the frozen ground up near the Route 7 ramp. 1/30/04 - Absorb-all was placed and then swept up, along with the very top layer of snow/soil. An original layer of absorbent pads were placed and then removed and a fresh layer is in place. 1/30/04 - The entire area is slated for excavation and removal next week as it is considered with the contaminated soil area. 1/30/04 	<ul style="list-style-type: none"> - The contractors should remain vigilant about securing and handling fuel containers due to the sensitivity of the area - Continue to keep all vehicles maintained well (i.e. no apparent fluid leaks) if they will be used or stored on site. - The practice of using “diapers” is highly encouraged for any vehicle or equipment with a known leak. - Report spills to the office immediately, even if they are being controlled.

VIEW OF AREA UNDER CRANE WHERE THE SMALL SPILL TOOK PLACE. A SECOND
LAYER OF ABSORBENT PADS ARE STILL IN PLACE. 1/30/04
